Engineering News

Volume 76, No. 19
Issued Every Thursday
Hill Publishing Company

NEW YORK, NOVEMBER 9, 1916

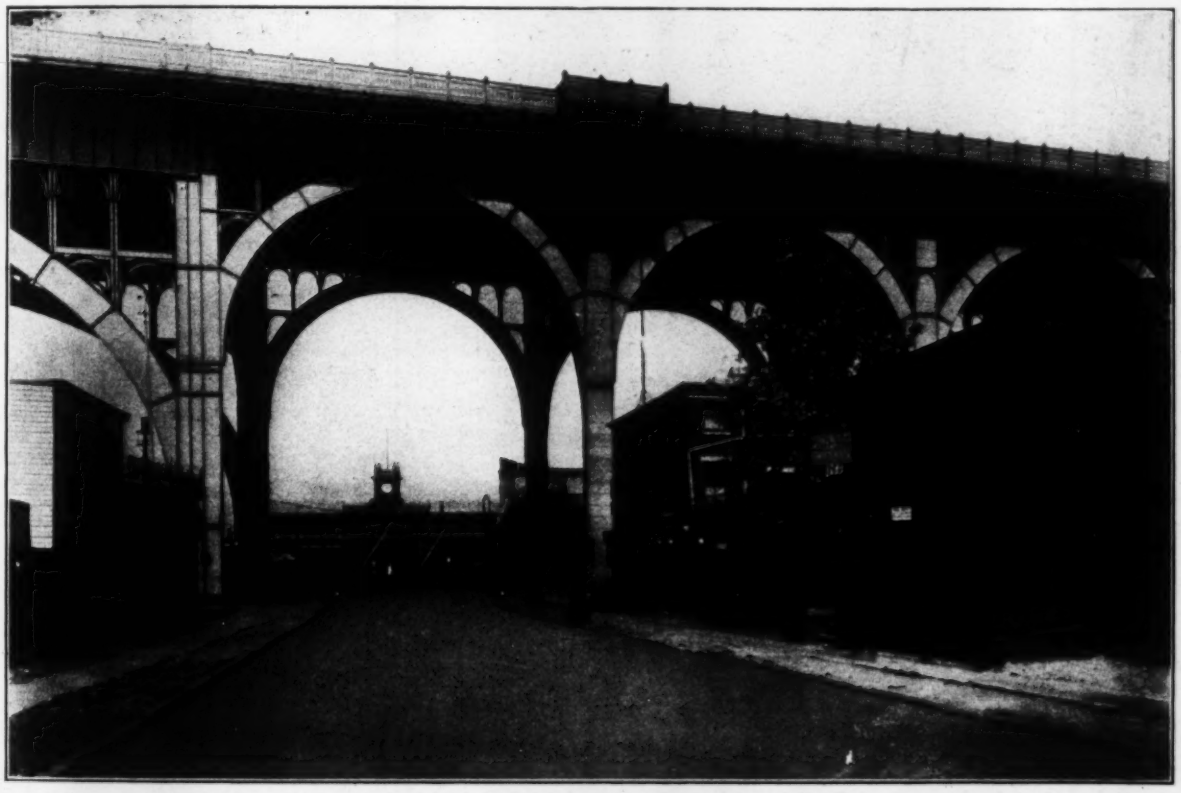
FIG. 1. RIVERSIDE DRIVE VIADUCT, SHOWING TWO OF THE SETTLED BENTS AT THE RIGHT; THE LARGE ARCH IS TO THE LEFT

Some time in 1912 the roadway on the viaduct was seen to show a marked sag in the length of a few hundred feet north of the large arch. Levels were taken on the footings, and it was found that two or three bents had settled, to a maximum of about 7¼ in. Presumably the settlement had existed longer, but maintenance and inspection during the dozen preceding years had apparently not been close enough to give information on the settlement. Plans for repair were made in 1915, and the work was taken in hand during the past summer.

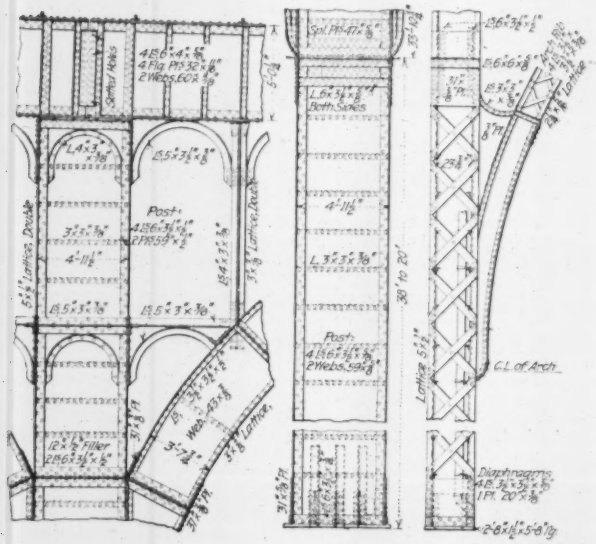
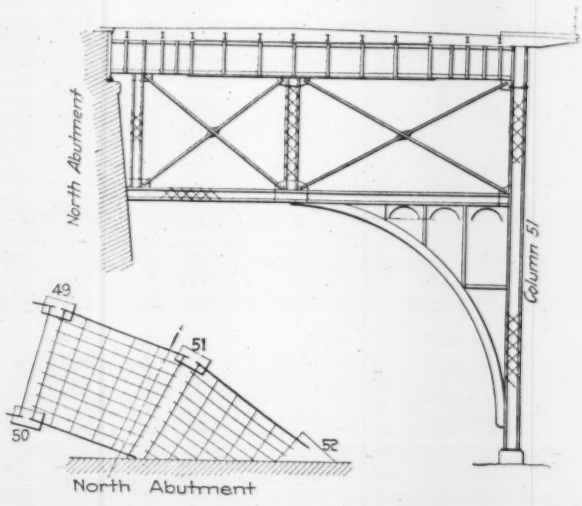
FIGS. 2 AND 3. DETAILS OF RIVERSIDE DRIVE VIADUCT AFFECTED BY FOUNDATION SETTLEMENT

The columns are founded on a concrete spread footing supported by piles cut off about 2 ft. below water level, or 10 to 13 ft. below street level. Each column has 16 piles, giving over 8 tons dead-load per pile.

In spite of the settlement the engineers of the Bureau decided to rely on the old foundations without reinforcement or other change. This decision determined the general nature of the repair job.

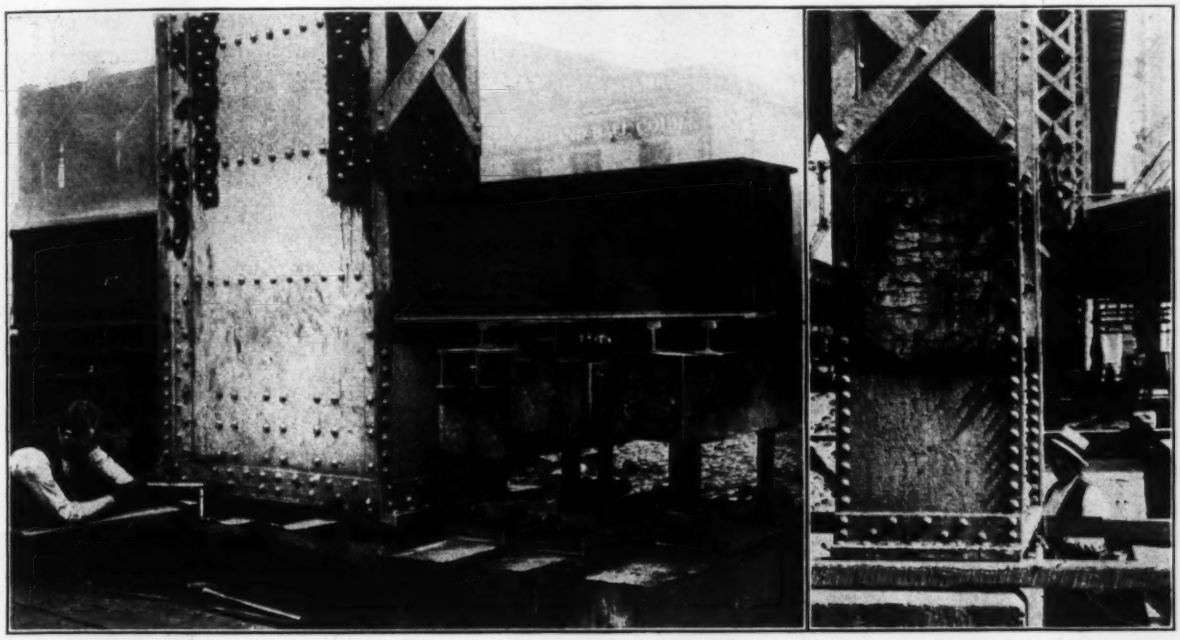
Lateral displacement of the columns complicated the matter. All of the six columns were out of position before work started; three were east of true position by amounts of 1¼ in., 1¼ in. and 3 in. respectively.

FIGS. 5 AND 6. COLUMN 18 DURING AND AFTER JACKING, SHOWING REINFORCING PLATE AND RESIDUAL KINK

Cast-steel jacks of the type ordinarily used in house raising failed by the threads shearing out of the nuts. Jacks of forged steel were then employed, with full satisfaction, except that the work was hard and slow. The men made a quarter-turn on one pair of jacks, then proceeded to the next pair and then to the third. It was thought during the work that hydraulic jacks would have proved more convenient, and amply safe if used with screw jacks as follow-ups. The amounts the six settled columns were jacked are shown in the accompanying tabulation.

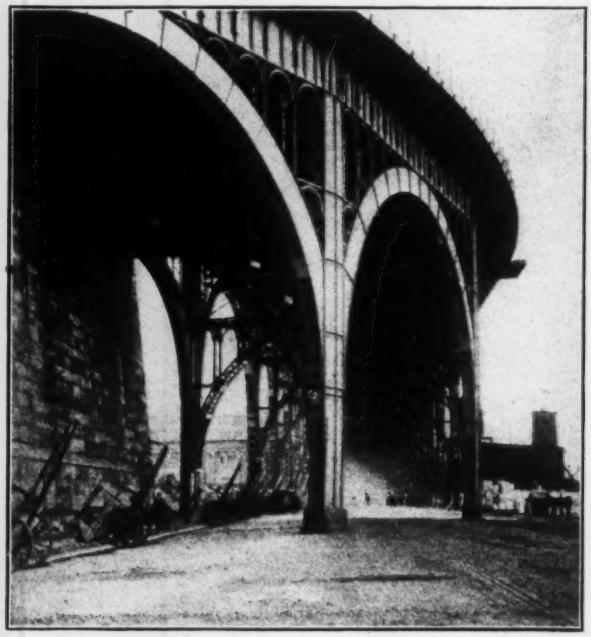
FIG. 8. NORTH END OF VIADUCT; COLUMN 51 IN FOREGROUND

Supplementary to the present repair work is some work on the northerly two bents of the viaduct, Cols. 49 and 50 and Col. 51. The latter is of serious concern in the viaduct.

When this condition was discovered, the anchorage of the strut in the abutment was cut. This resulted in decreasing the bend in the column by ¾ in.; the strut moved east by this amount, and its east end also moved north 2 in. The residual bend in the column, which is clearly visible, measures about 5 in. (Fig. 8). Steel bolsters will be inserted through the pier cap stone to support the column, and the column will be filled with concrete.

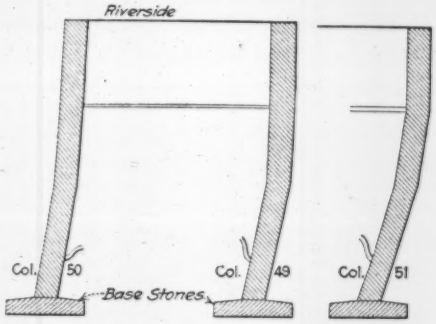
at the same time as much as ½ in.; thus there was at the worst place a total buckling distortion of the web of over ¾ in. out of its plane, in a relatively short wave. This evidently denoted a very threatening failure of the web plates to do the work of load-carrying that they were expected to do.

FIG. 9. DIAGRAM SHOWING RESIDUAL BEND IN VIADUCT COLUMNS
Horizontal scale 1 in. = 20 in.

There is a similar bend in both columns of the pair next south, Cols. 49 and 50. Their condition is sketched in Fig. 9. The treatment here will be the same as for Col. 51. The distortion of this bent is probably due to the action that pushed Col. 51 over, the effect being transmitted by the rigidity of the buckle-plate floor of the viaduct.
